NAVWEPS REPORT 7630
NOTS TP 2635

EVALUATION OF PROPELLANT DEFECTS USING TRANSPARENT ROCKET MOTORS

Henry T. Sampson
Propulsion Development Department

March 1961

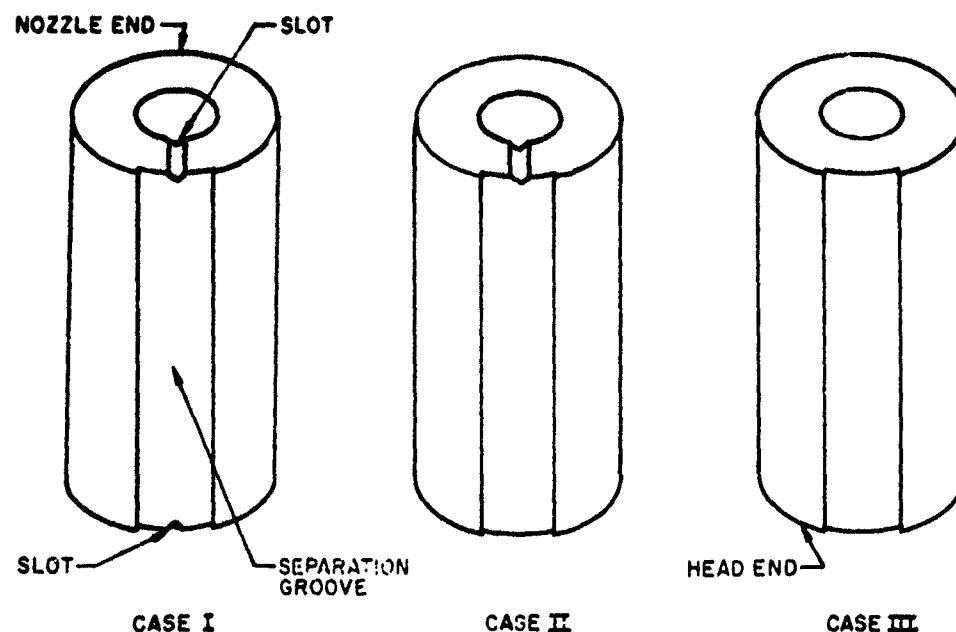
Certain defects were built into some motors by a modification of the fabrication method described above. Liner-propellant separation was achieved by placing a brass shim in contact with the liner surface before casting the propellant. The shims were coated with silicone rubber RTV 60 to promote easy removal from the motor. Shim thicknesses were varied according to the design of the experiment. After the propellant was cast and cured, the shim was removed leaving a portion of the propellant surface adjacent to the liner uninhibited and separated. V-shaped slots machined in some of the motors were positioned so that the uninhibited or separated area was connected by a channel, which permitted possible gas flow to this area from the main internal cavity of the motor. This configuration and its modifications are shown in Fig. 2 and are identified as Cases I, II, and III.

FIG. 2. Configuration of Motor Defects.

This experiment was conducted in an effort to study the behavior of test motors containing known amounts of liner-propellant separation, and to determine the conditions under which side burning would occur. The design and test data of this experiment are shown in Table 1. Each of the 2-inch motors, with the exception of motor No. 4, contained a surface section of propellant that was separated from the liner. Three motors had the configuration shown in Case I, 3 had that shown in Case II, and 3 had that shown in Case III (Fig. 2). All 10 were fired at ambient temperatures ($75 \pm 5^\circ\text{F}$).

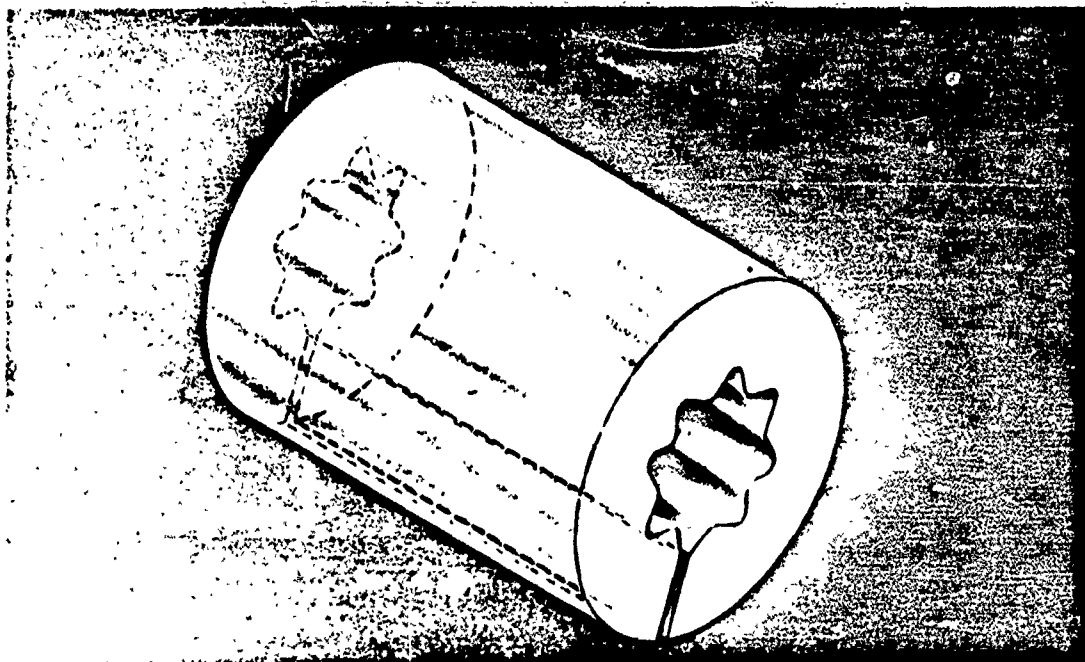
The second motor defect fabricated (Fig. 3) was a simulated crack in the propellant grain. This was achieved by placing a silicone-coated

FIG. 3. Configuration of Cracked Grain.

metal shim parallel with the mandrel so that it extended from the tip of a star point perpendicularly to the surface of the liner. This strip of metal was removed after curing of the propellant. The position of the crack was chosen to conform to the point of maximum stress in a normal grain under internal pressure. The grain would most probably crack at this position because of thermal stresses during severe temperature cycling. The shim thickness used was 0.010 inch, and the actual measured crack sizes varied between 0.010 and 0.014 inch.

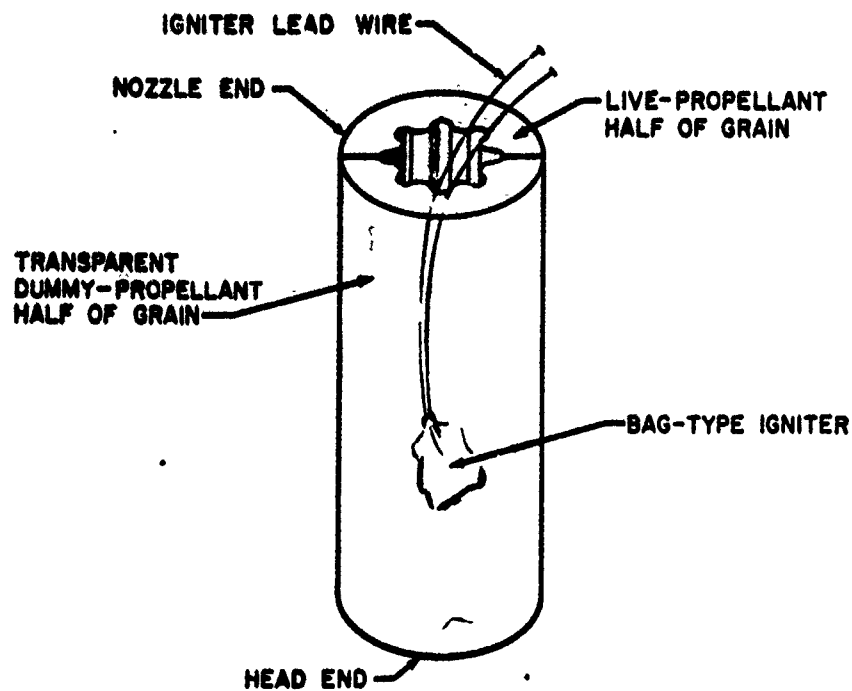
A third type of grain used in this program (Fig. 4) permits observation during ignition of the propellant. The grain was made by casting half of the motor with the mandrel in position, with polyurethane resin R-1. After the inert material cured, the remaining volume of the motor was filled with propellant.

FIG. 4. Half-Motor Grain Design for Ignition Study.

The grain configuration shown in Fig. 4 was used to study the performance of bag and hot-wire igniters. Using this arrangement, ignition of the propellant was observed and studied qualitatively. The use of a half grain permitted the observation of the igniter and the propellant surface during ignition of the motor. The motor was designed so that the ratio of the burning-surface area to nozzle-throat area was approximately the same as that for the control motor used in the liner-separation experiment. The design operating pressure was 1,000 psi. The sequence of photographs (Fig. 16) shows various stages of the ignition of a propellant grain, using bag igniter. The pictures show that the flame pattern within the cavity is not symmetrical, and approximately all of the propellant surface is ignited before hot gases can be seen emerging from the nozzle. BCT data indicated that 176 milliseconds were required for the igniter to respond to the initial input of current and begin to burn. This interval is sometimes referred to as igniter delay. A total of 55 milliseconds was required for the entire propellant surface to ignite after the initial igniter response. Pressure data were lost during this test, and therefore picture sequences could not be correlated with motor pressure.

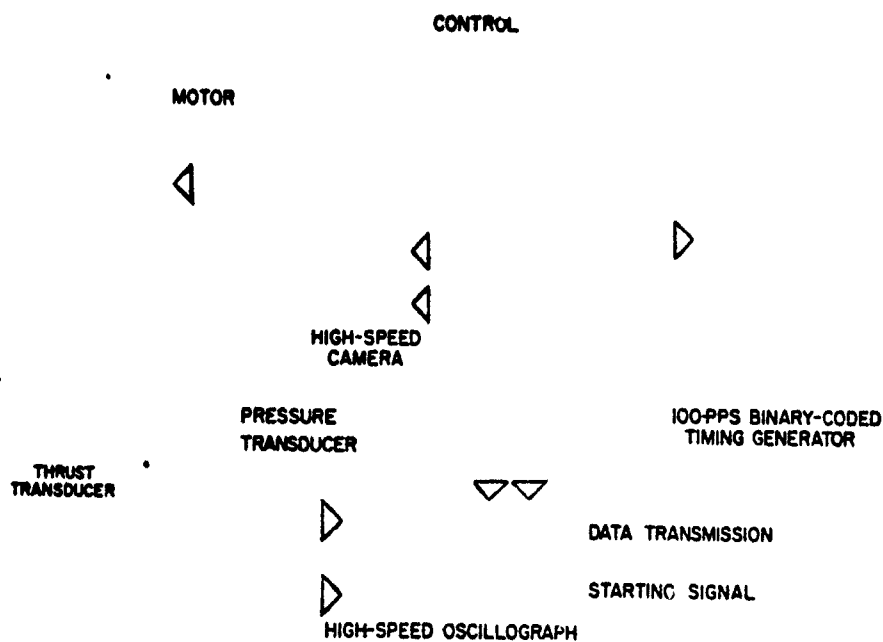
FIG. 5. Instrumentation Arrangement for Tests of Transparent Motors.

signals from the timing generator were sent to the recording oscillograph and to neon lamps mounted inside the cameras. By comparing timing lines that appeared both on the oscillograph and on the motion picture record, film frames could be matched with a point on the pressure and thrust records. Observed phenomena associated with motor operation were thereby correlated with motor pressure and thrust. The 100-pps BCT unit developed at NOTS² provided a binary display at elapsed time every 0.1 second for 51.1 seconds. To ensure accurate counting between intervals of the coded signals, pulses of 1 kc were injected into the coded signals. A block diagram of the instrumentation arrangement is shown in Fig. 5, and the actual motor in the test stand is shown in Fig. 6.

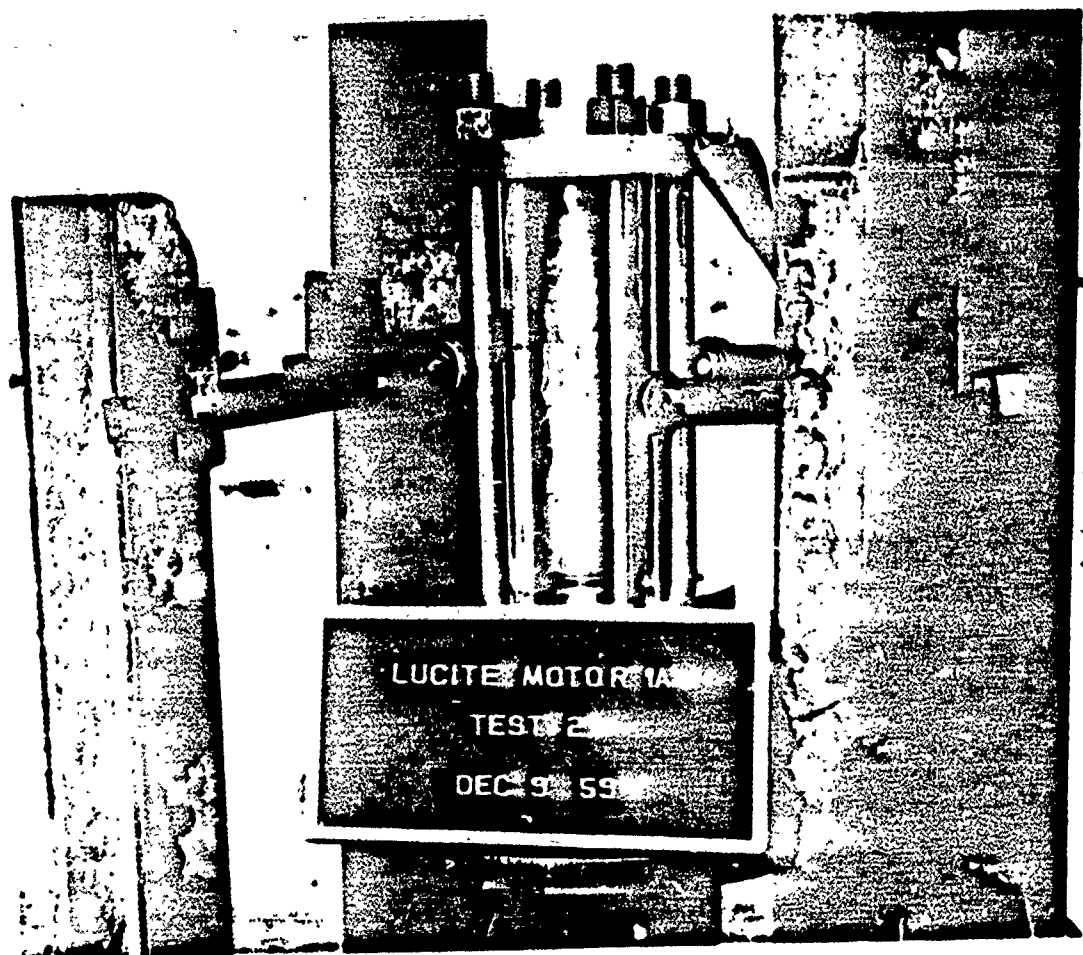
FIG. 6. Transparent 2-Inch Motor on Test Stand.

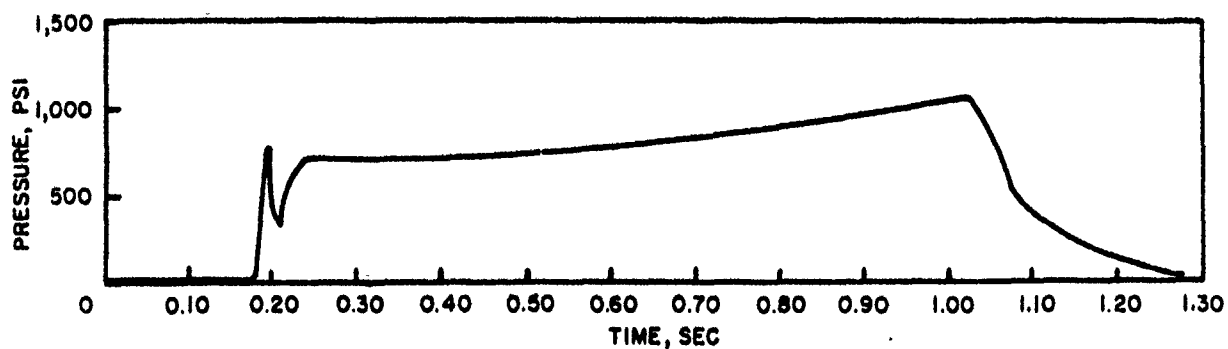
FIG. 7. Pressure-Time Curve, 2-Inch Control Motor No. 4.

The pressure-time curves are shown in Fig. 7 through 10. Figure 7 shows that the pressure-time history of the control motor is progressive. The internal configuration of the grain causes the burning-surface area to increase until web burnout. Test results are useful, however, since the curves for the abnormal cases were compared with that for the control round. Differences in total impulse of motors are caused by differences in propellant weight.

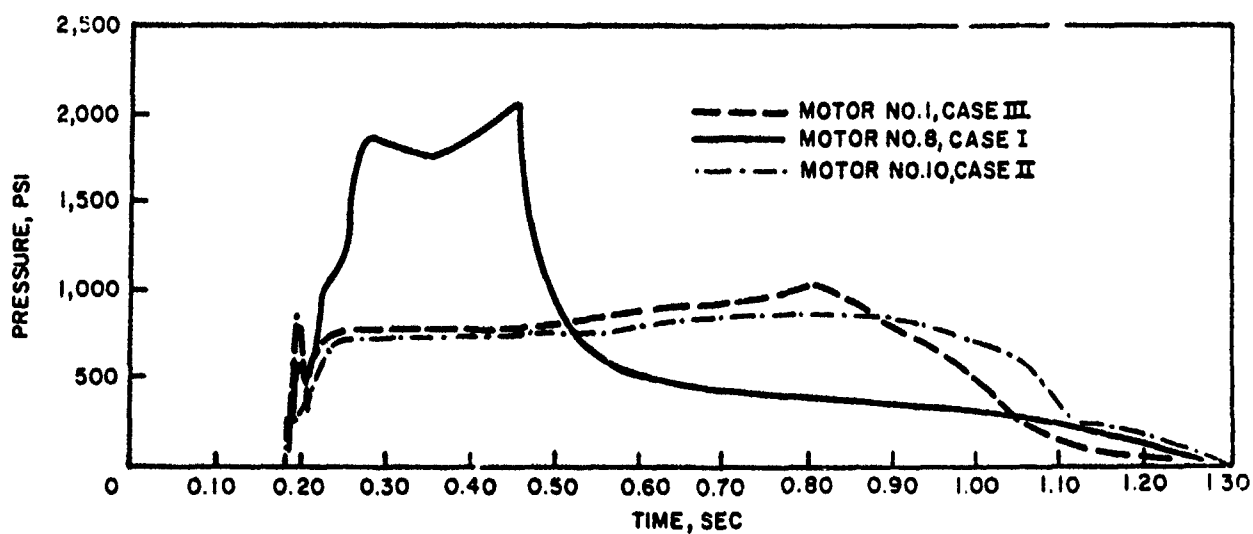
FIG. 8. Pressure-Time Curves, 2-Inch Motors No. 1, 8, and 10.

Results show that abnormal curves were obtained only from motors containing Case I defects. Motors No. 2, 8, and 9 show secondary pressure peaks occurring during various stages of motor operation. The peak for motor No. 2 occurred during the initial stages of burning, and the peak for motor No. 9 occurred during the latter stages. Film records were not obtained for motors 2 and 8 because of camera failures. The film record for motor 9, however, proved that the existence of the peak shown on the pressure record was due to side burning at the liner-propellant interface. This phenomenon was observed directly through the walls of the Lucite motor tube. Figure 11 is a picture sequence of

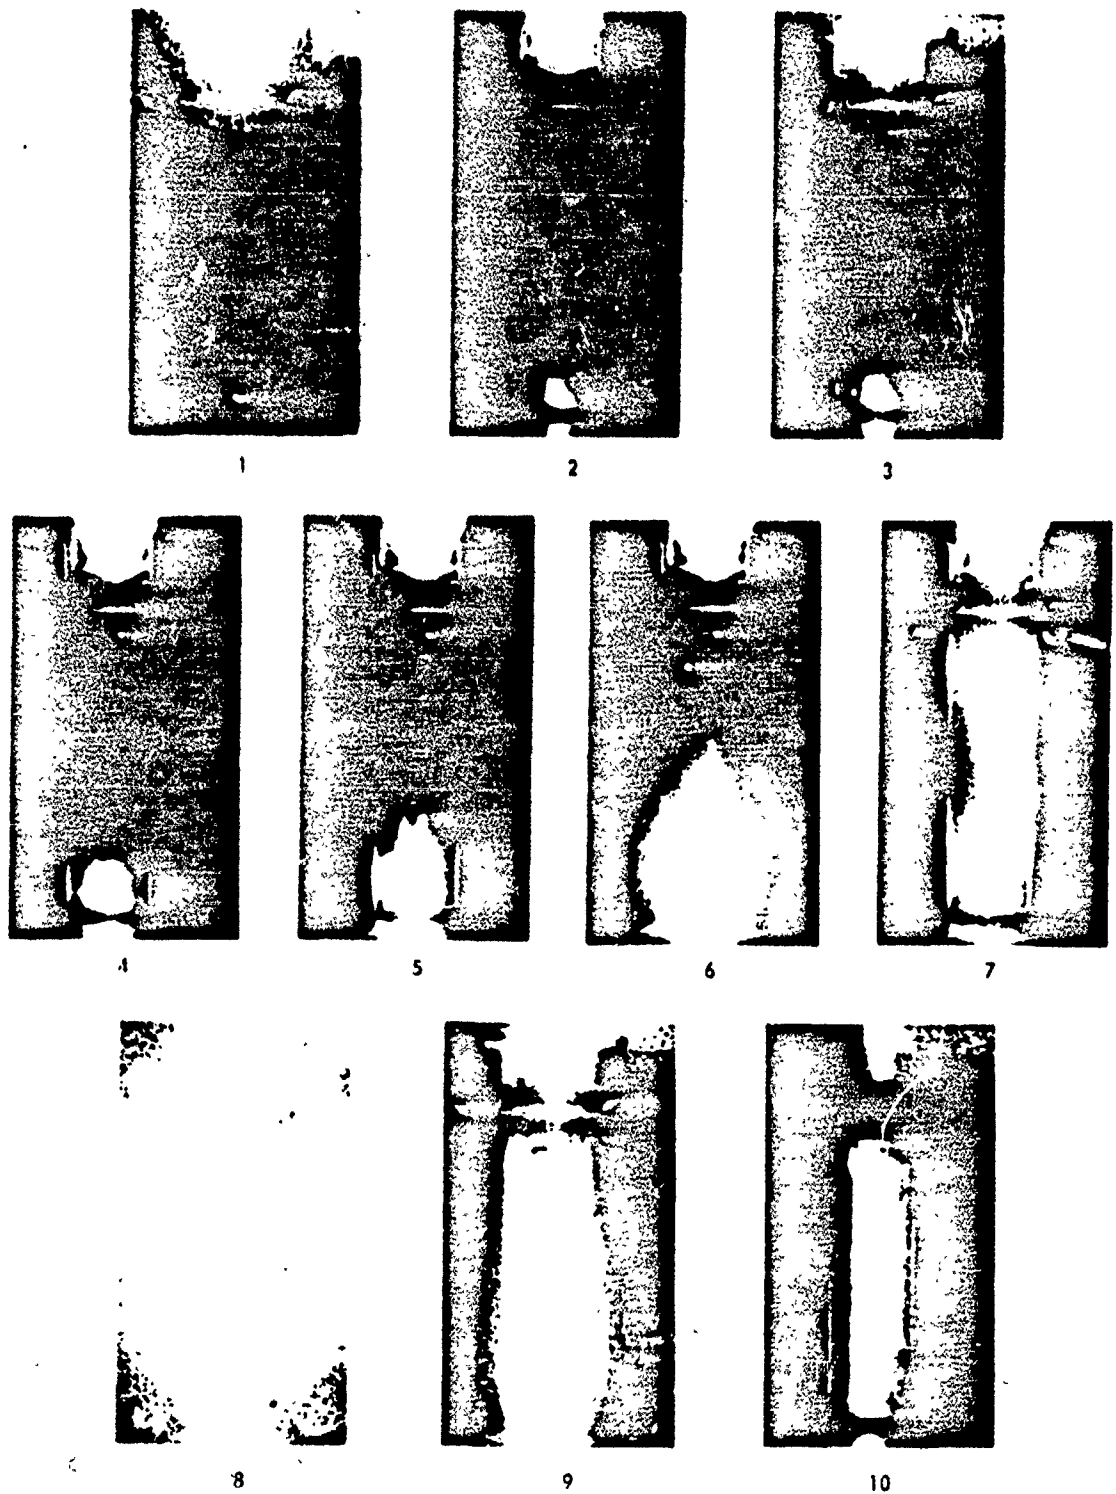
FIG. 11. Side Burning in 2-Inch Motor No. 9. Numbers correspond to numbered points in Fig. 10.

motor 9 during operation. Each picture was matched to a point on the pressure-time curve for this motor (Fig. 10). The numbers 1 to 10 on the curve in Fig. 10 correspond to the views 1 to 10 in Fig. 11. From these data it was concluded that the peaks for motors 2 and 8 were also caused by side burning.

From the film record of motor No. 9, a rate of ignition in the separation groove was calculated to be 20 in/sec. This value is 40 times higher than the normal propellant burning rate. One observing the position of the secondary peaks in the pressure-time curves for motors No. 2 and 8 shown in Fig. 9 and 10 might suspect that the ignition rates are higher for these motors. An attempt was made to correlate the position of the secondary peaks with the separation distance for these motors. Motor No. 8 had the largest separation distance, and, as expected, the peak occurred almost simultaneously with ignition. The peaks for motors 9 and 2, however, occurred in reverse positions relative to separation distances in each motor. This behavior could be caused by inaccurate measurements or, more probably, by the nonuniform separation in all motors.

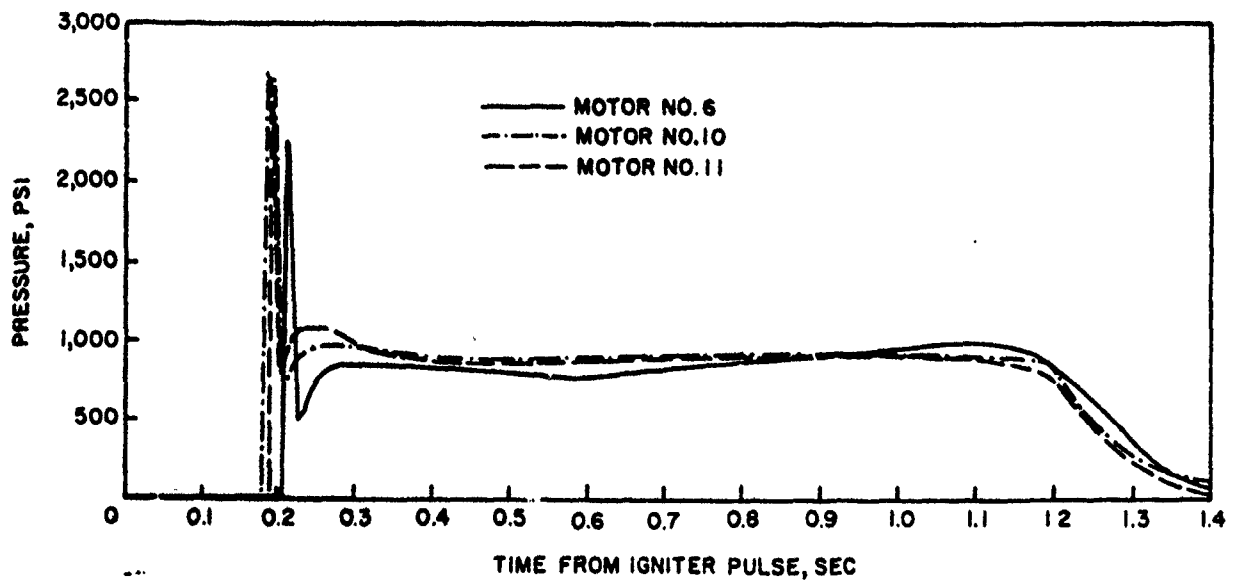
FIG. 14. Pressure-Time Curves, 2-Inch Motors No. 6, 10, and 11.

experiment and a summary of firing data. The corresponding pressure-time curves are shown in Fig. 13, 14, and 15. Motor No. 15 at 70°F and the control motor No. 9 at 120°F blew up. Photographic coverage was lost for these two motors, and, as a result, an explanation for their unexpected failure cannot be given. Extremely high initial-pressure peaks were obtained from all motors of this test series, including the control motors. Through a mistake in processing the propellant for these motors, coated ammonium perchlorate was used instead of the uncoated material. The higher pressure exponent of this material may have caused the high initial-pressure peaks.

These data indicate that the presence of a crack in the grain does not necessarily cause failure of the 2-inch motor. In fact, with the eight-point-star internal configuration, the presence of a crack changes the burning pattern of the grain from progressive to regressive. The progressivity ratio (ratio of burning surface at web burnout to initial burning surface area) changes from 1.28 without the crack to 0.73 with the crack. This effect is reflected in the pressure-time curves shown in Fig. 13. Because the propellant has a high temperature coefficient, the amount of progressivity or regressivity in the pressure-time curves is dependent upon the temperature of the grain before testing. This is seen by comparing the curves in Fig. 13 through 15. The pressure-time curves for the 120°F firings seem to be abnormal, having rather broad initial peaks. It cannot be determined, however, whether this is the result of temperature or of a crack in the grain, since the control motor fired at this temperature blew up.

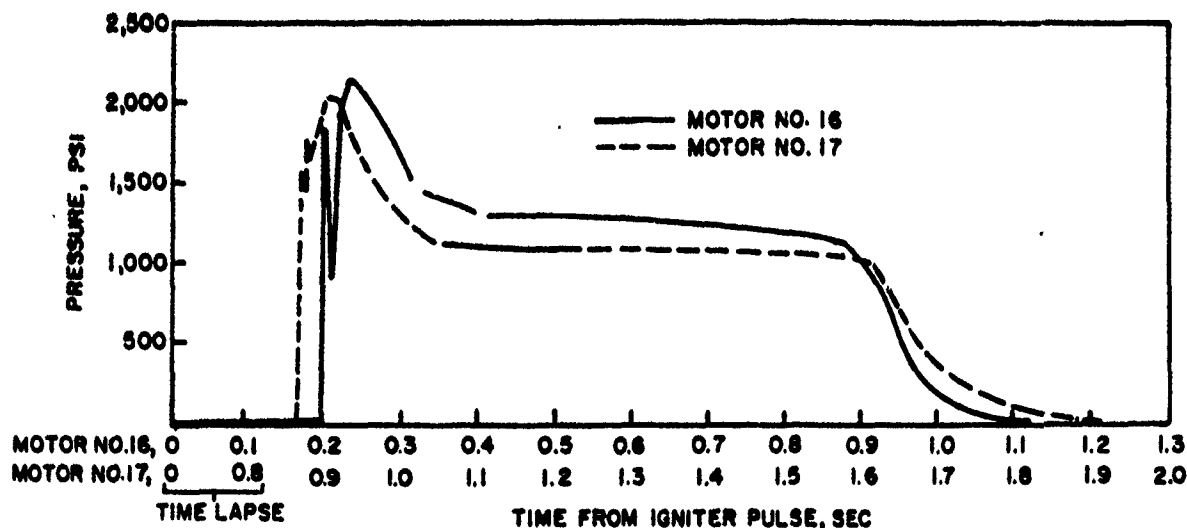
FIG. 15. Pressure-Time Curves, 2-Inch Motors No. 16 and 17.

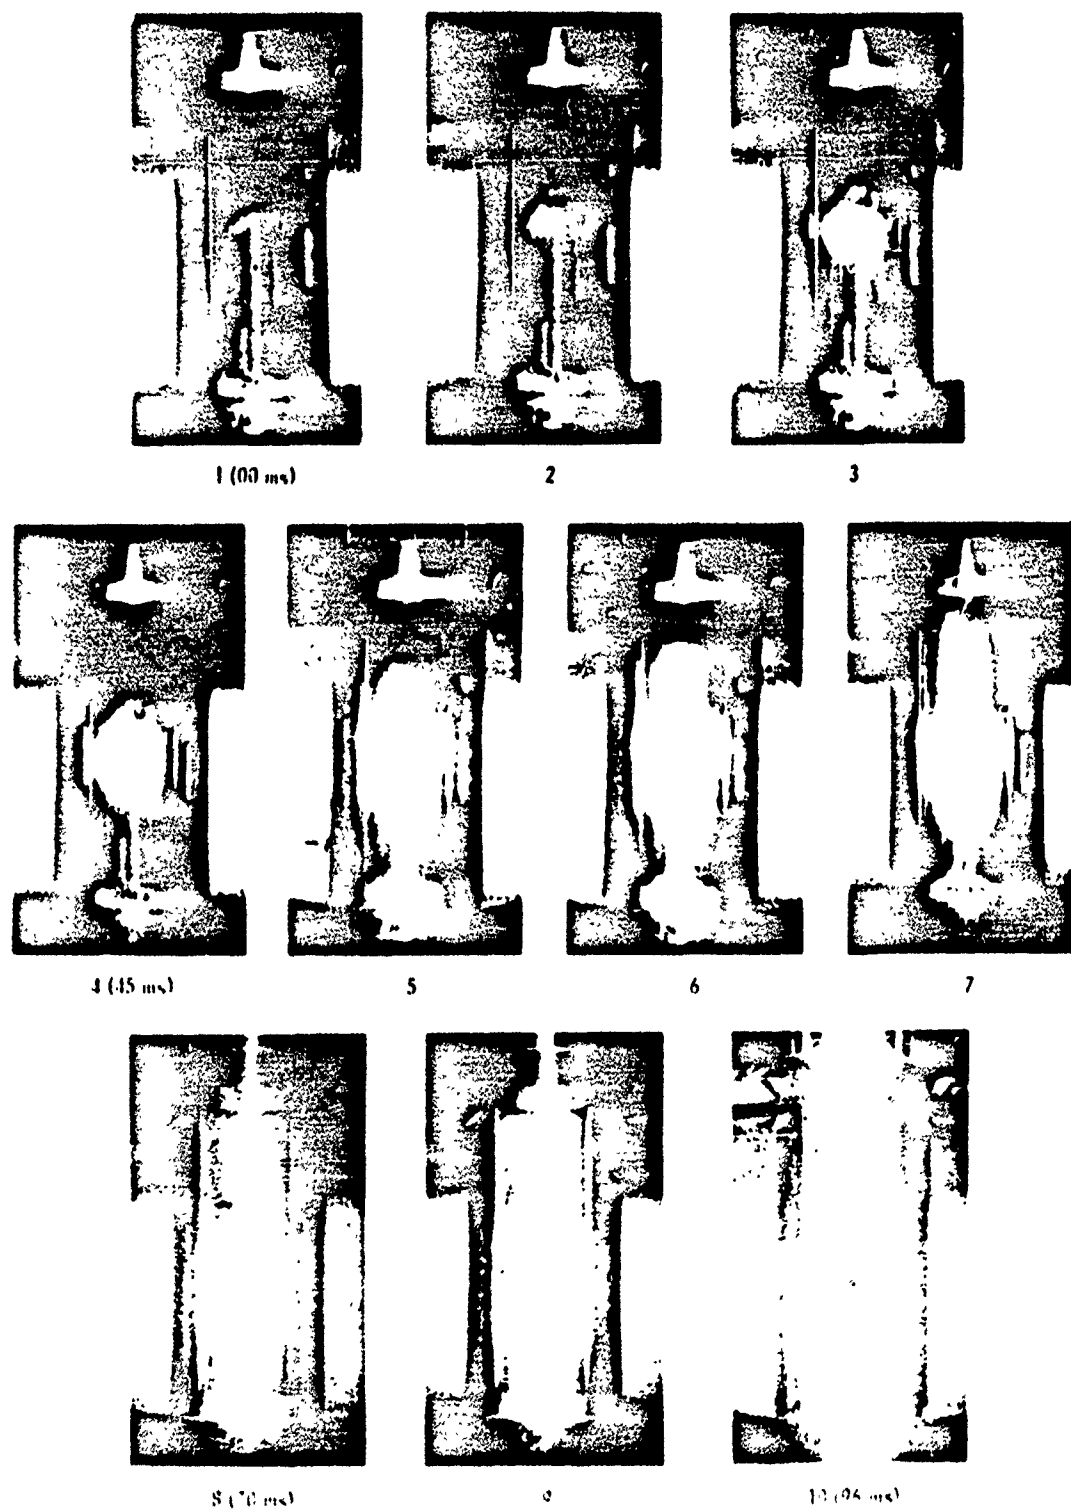
A hot-wire igniter was also studied. This igniter consists of a helix of high-resistance Nichrome wire, 0.010 inch in diameter, inserted into the cavity of the motor so that it is in contact with the propellant. The igniter is actuated by a current of 18 amperes. In contrast with the bag type, this igniter gave a long ignition delay. Ignition of the propellant proceeded as follows: The igniter responded as indicated by a red glow emitted by the hot wire 0.654 second after the current was applied. The whole length of wire began to glow after 0.721 second. The wire appeared to break up, and the propellant smoldered, but no aluminum

FIG. 16. Ignition of Half-Motor.

burned after 1.176 seconds. The entire propellant surface smoldered with little burning of aluminum inside the motor at 4.459 seconds. The entire surface of the propellant appeared to burn with combustion of aluminum at 4.759 seconds. The motor pressure at this time was 52 psi. The motor reached 250 psi at 4.804 seconds. This motor failed after 0.109 second of operation at a pressure of 1,930 psi. An examination showed that the propellant surface was irregular with equally spaced depressions. It is concluded that these depressions occurred at points of propellant contact with the coils of the wire igniter. The propellant first ignited at these points. This experiment showed the difference in ignition characteristics between the bag and hot-wire igniters.
